MAMMOMAT Novation

Troubleshooting Guide

Mammomat Novation DR

Print No.: SPB7-250.840.01.01.02
Replaces: n.a.

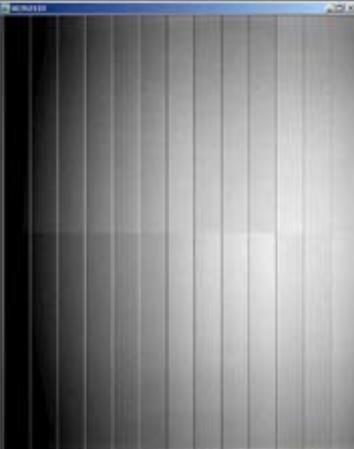
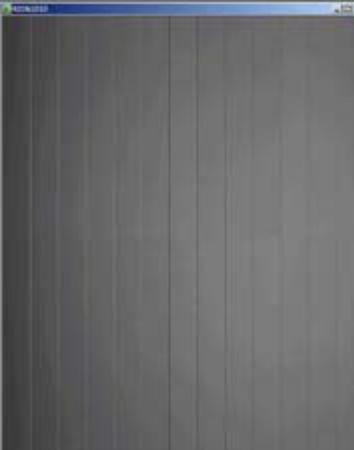
Bad lines appear during calibration	After gain calibration, turn the whole system OFF. Turn the system ON and repeat the gain calibration.

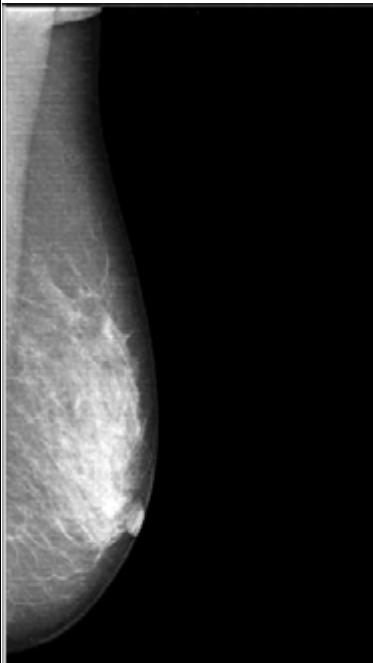
Grid lines are visible on image.	<p>Check exposure parameters: If exposure time is very short (e.g.: pre-shot), grid lines can be visible on image. In this case, select the appropriate exposure parameters.</p> <p>To eliminate grid lines, check the grid adjustment according to the Startup Instructions, SPB7-250.815.., Chapter 9.:</p> <ul style="list-style-type: none">Adjusting the grid switchAdjusting the “wheel”Adjusting the grid locationAdjusting the grid speed <p>If not successful, refer to Replacement of Parts, SPB7-250.841.02.01.02.</p>

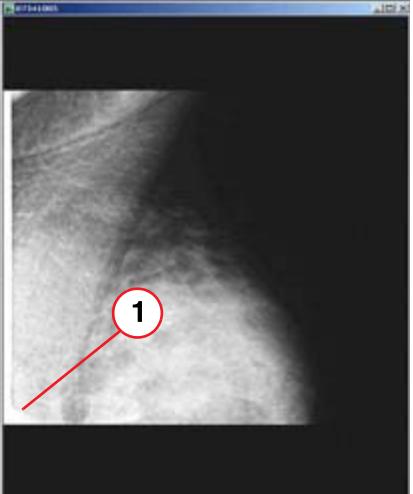
Edge of compression paddle visible on image	Replace compression paddle Adjust the whole compression unit according to Replacement of Parts SPB7-250.841.01...

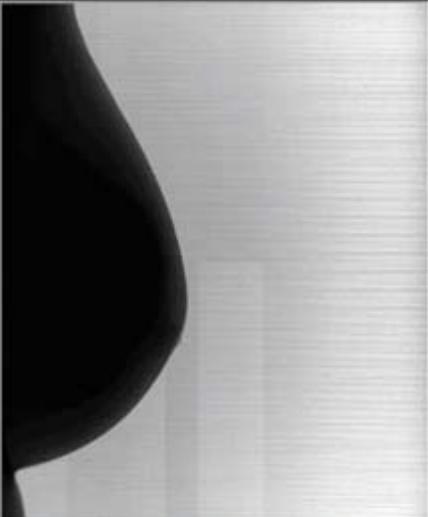
A mammogram of a breast. The image shows a dark, irregular shape on the left and a lighter, textured area on the right. There are visible horizontal lines and artifacts across the entire image, indicating detector motion during acquisition.	Lines and artifacts visible on image. Detector motions during acquisition of image data	Repeat image acquisition and be sure there is no motion during image data transfer. If successful, inform the customer about handling during data acquisition.

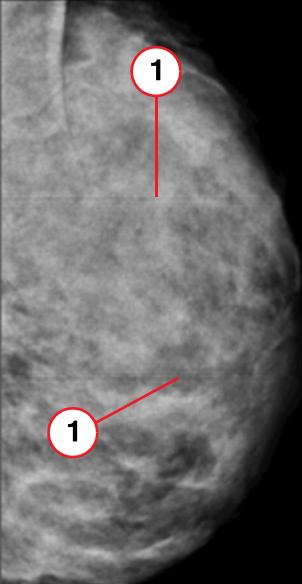
A mammogram of a breast. Two specific areas are highlighted with red circles and labeled with the number '1'. One circle is located near the top left edge, and the other is located near the bottom left edge. The rest of the image shows a textured breast tissue.	Lines and artifacts visible on image. Detector motions during acquisition of image data	Repeat image acquisition and be sure there is no motion during image data transfer. If successful, inform the customer about handling during data acquisition.

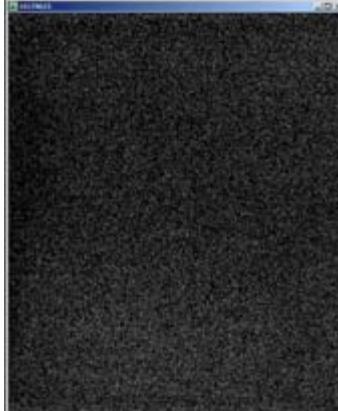
Many spots are visible on image	<p>Reboot the whole system.</p> <p>If not successful, perform an exposure with the collimator-mounted plexi-phantom and QC-Raw.</p> <p>If not successful, perform gain calibration procedure.</p> <p>If not successful, perform bad pixel mapping correction.</p> <p>If not successful, the detector may need to be replaced. Contact USC/HSC.</p>

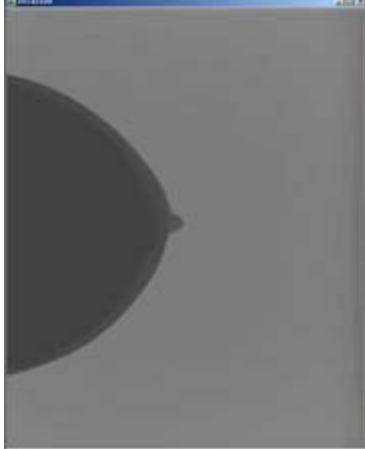
Dose for exposure too low, or acquisition aborted by user, or acquisition was terminated before exposure was completed.	Check exposure parameters. Exposure time probably too short Check generator values according to the Troubleshooting Guide, "Generator checks" chapter, (these instructions.)
